**PHOTO LOG FOR GARY DEVELOPMENT LANDFILL, GARY, INDIANA
IND 077 005 916**

DEPARTMENT OF
ENVIRONMENTAL MANAGEMENT
OFFICE OF LAND QUALITY

Inspection conducted September 26, 1996

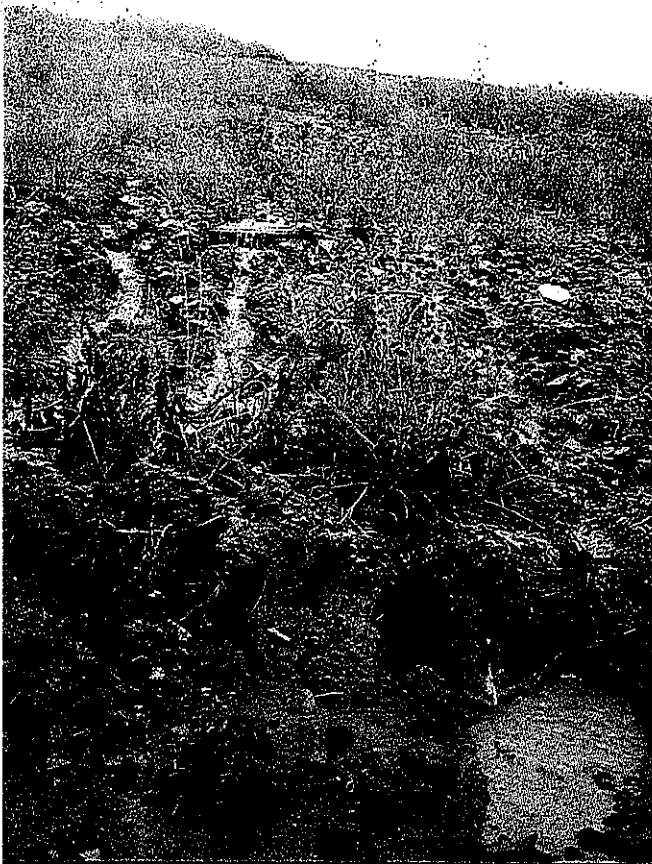
9-26-96 Bob Blaesing, IDEM
Gary Development Company
#1 -- View of GDC landfill, south
face. Note rill erosion, lack of
vegetative cover.

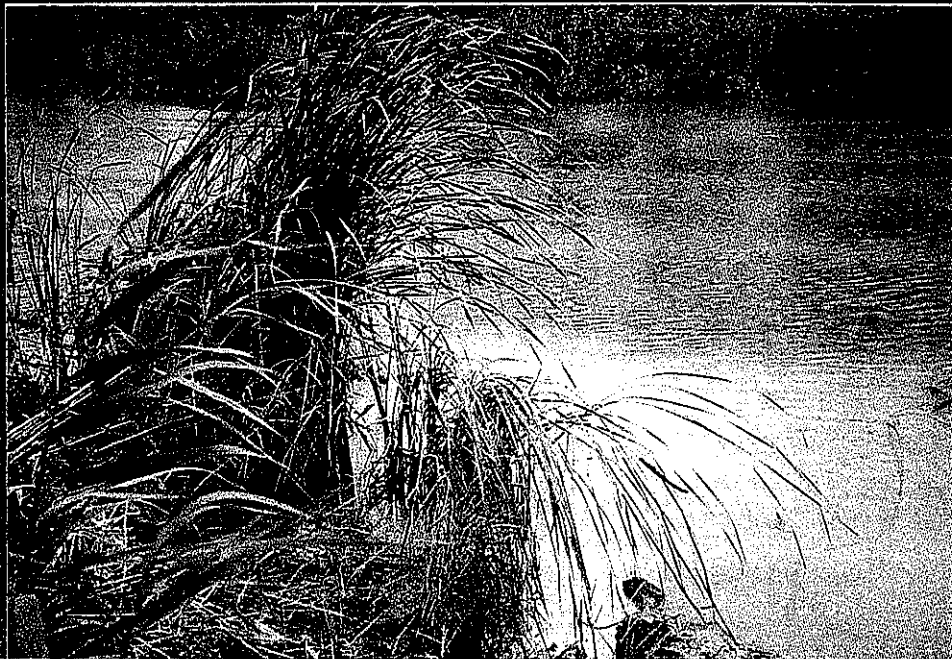
9-26-96 Bob Blaesing, IDEM
Gary Development Company
#2 -- Runoff from GDC entering
Grand Calumet River via gully
formed by erosion. Note River
discoloration (brown) due to clay
being carried in runoff.

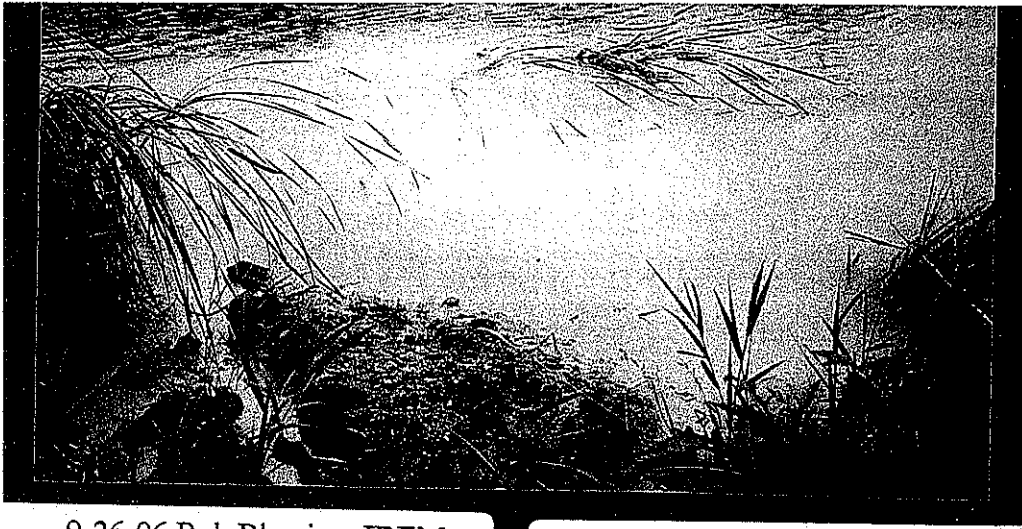
9-26-96 Bob Blaesing, IDEM
Gary Development Company
#3 -- More detailed view of gully
seen in photo #2, showing point
source nature of runoff from GDC

Note brown discoloration of
Grand Calumet River.

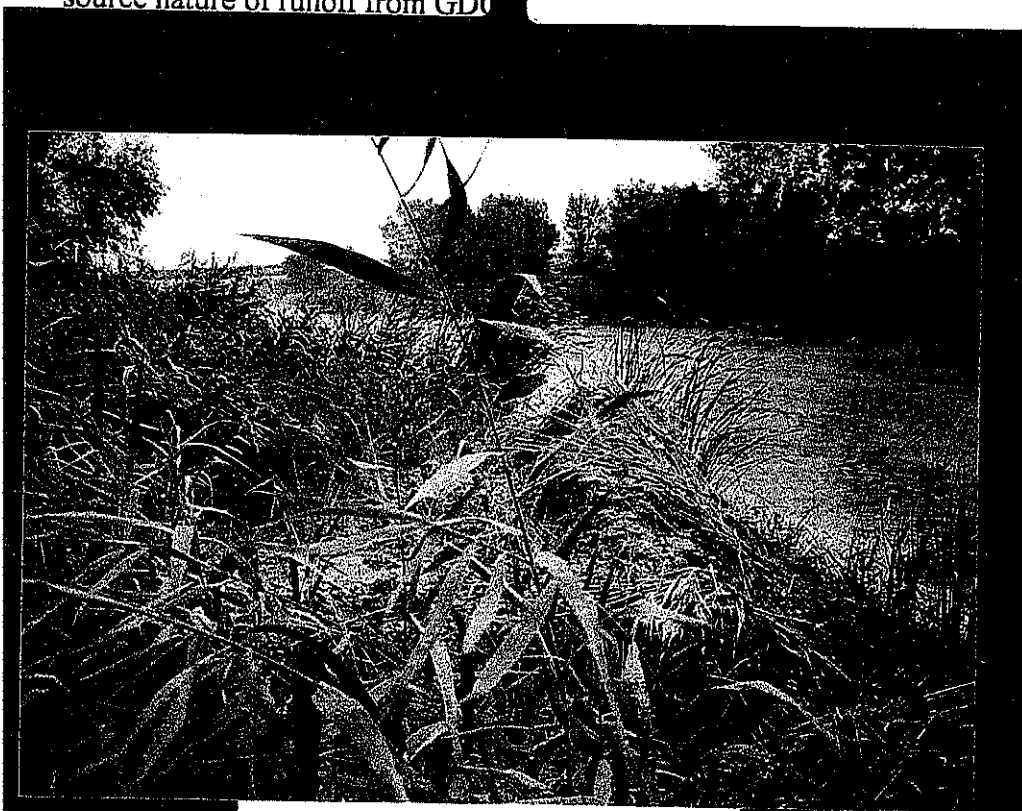
9-26-96 Bob Blaesing, IDEM
Gary Development Company
#4 -- View of pile of clay/dirt
dumped in wetlands area adjacent
to Grand Calumet River.

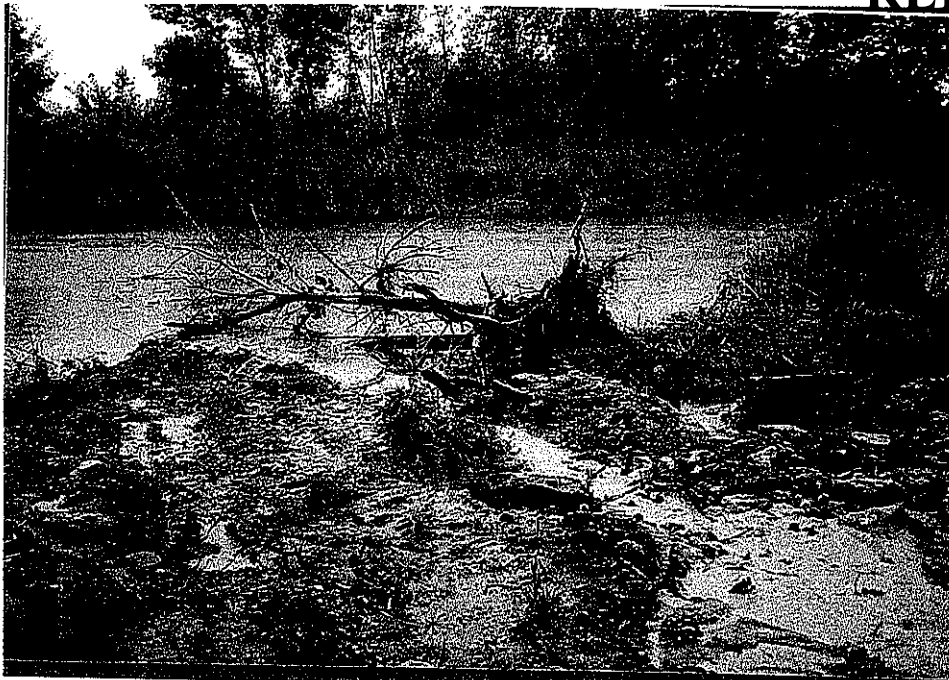
9-26-96 Bob Blaesing, IDEM
Gary Development Company
#5 -- View of point source and

sheet erosion from GDC property
to Grand Calumet River. Note
heavy clay load in runoff, and
brown discoloration of River.

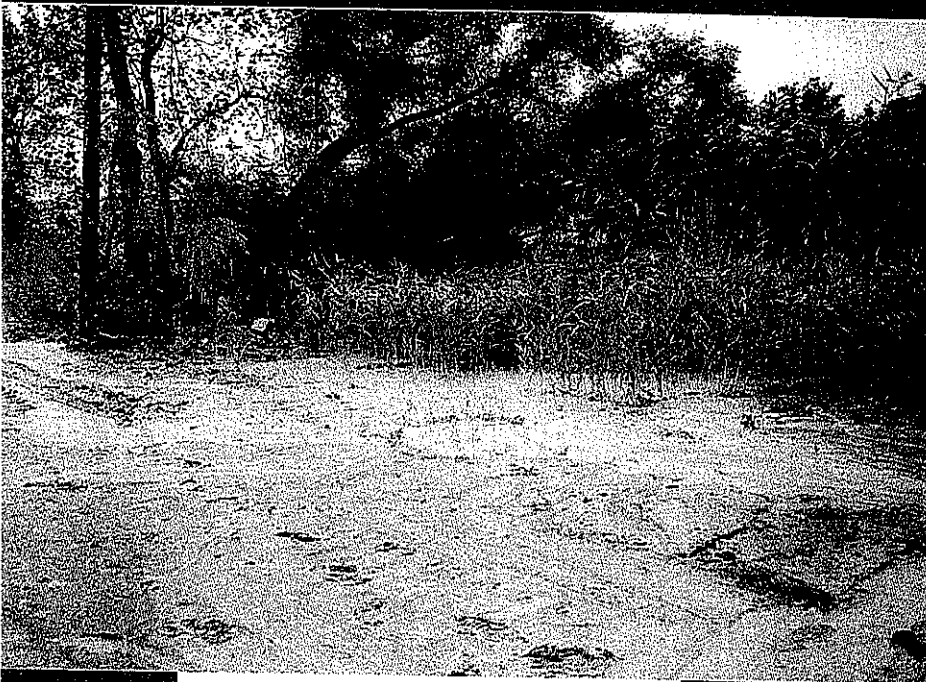
9-26-96 Bob Blaesing, IDEM
Gary Development Company
#6 -- View of erosion of clay cap
from GDC landfill and road
material into wetland area adjacent
to the Grand Calumet River.

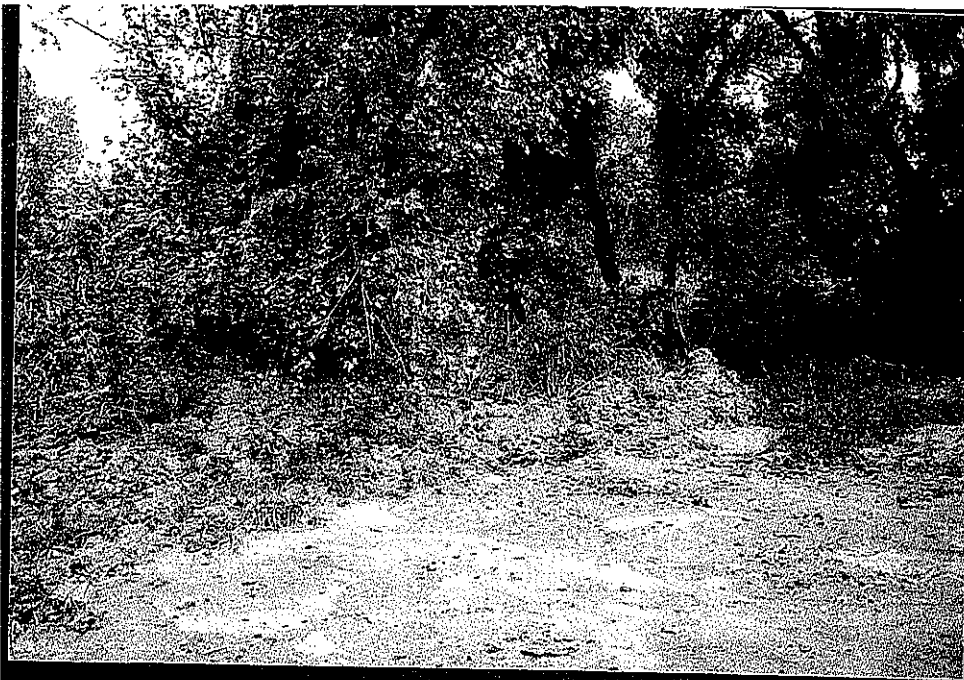
9-26-96 Bob Blaesing, IDEM
Gary Development Company
#7 -- View of cap and road
material which has been graded

into wooded wetland at GDC,
adjacent to the Grand Calumet
River at the GDC site.

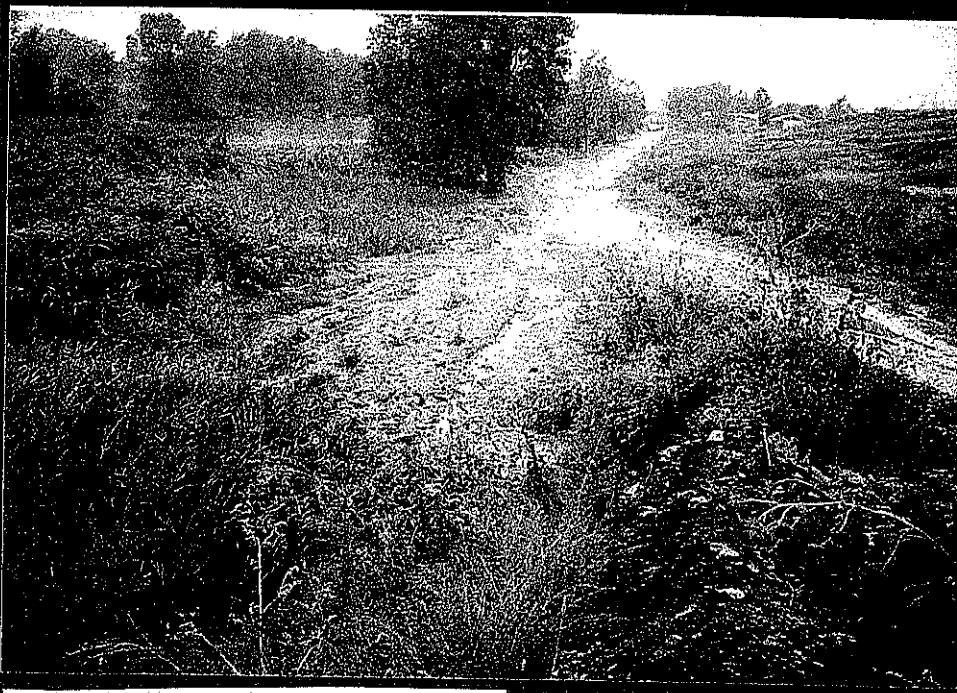
9-26-96 Bob Blaesing, IDEM
Gary Development Company
#8 -- View of road at GDC at toe
of landfill, which runs along Grand

Calumet River, as seen from point
at which road rises. GDC offices
in background. Note runoff and
rill erosion on slope into wetland
area.
